STS41G Left Wing Lost Tile (RTV Reversion)

STS41G Left Wing Impact Damage

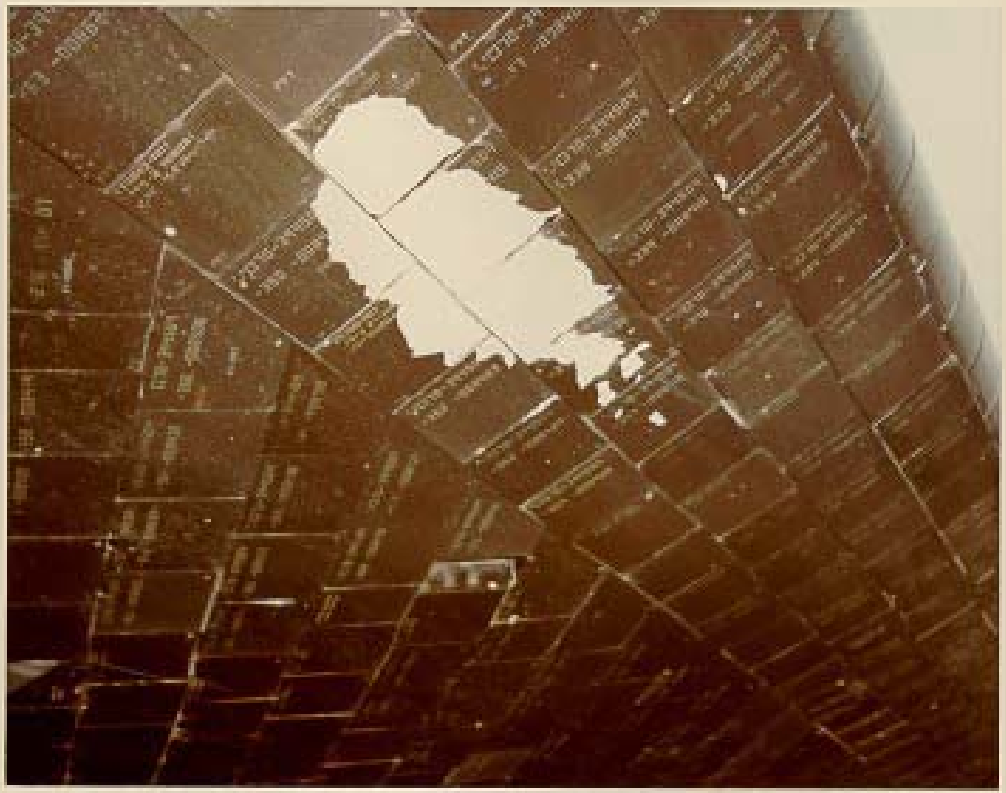
18. CLOSE UP, LOST TILE AREA (¶4.12.2)

19. OVERALL VIEW, LEFT WING GLOVE (¶4.12.2)

20” x 10” x 1.5”d

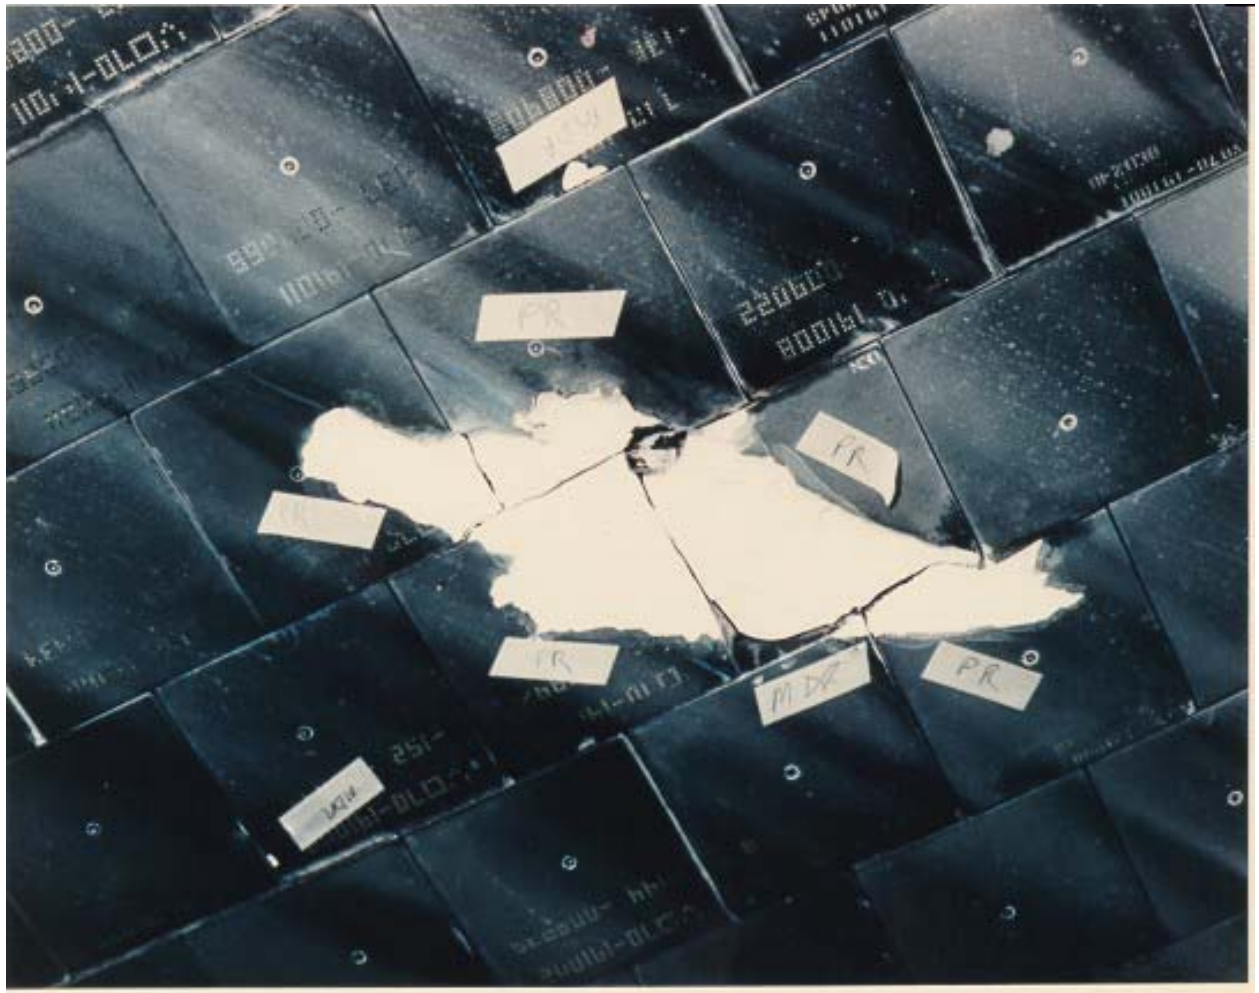
STS 26R Right Wing Impact Damage

PHOTO #6. CLOSEUP OF RIGHT WING DEBRIS IMPACT GOUGE

17.5” x 1.5” d

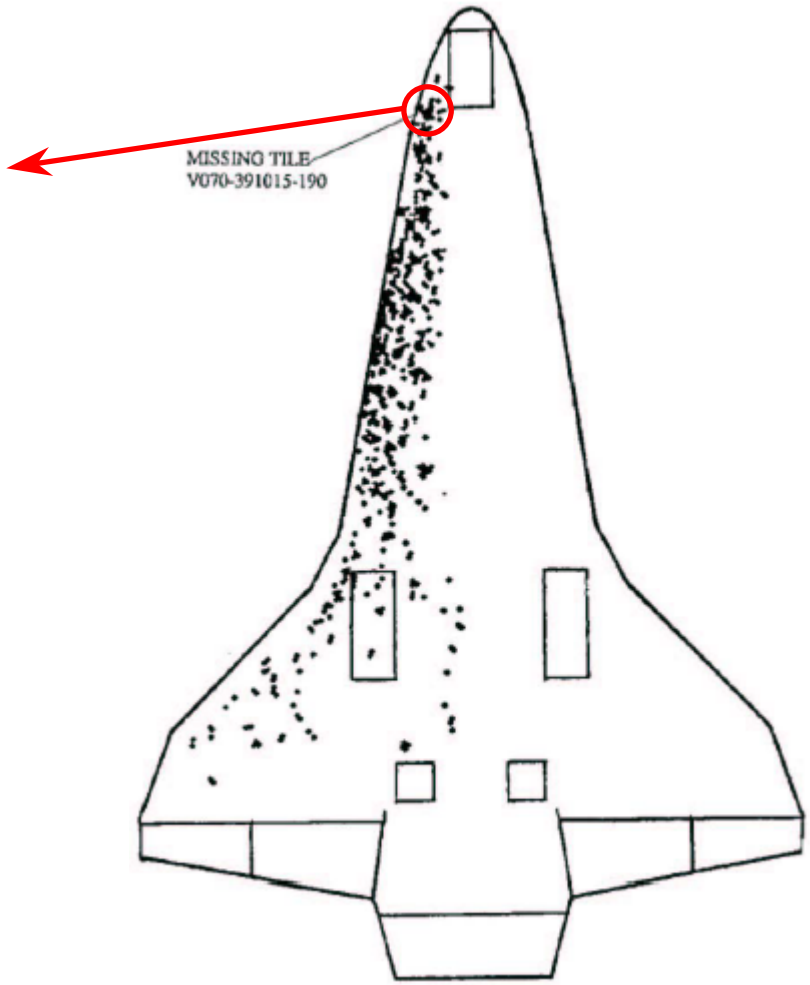
STS 27R Missing Chine Tile

PHOTO #2. MISSING TILE AREA, LOWER FORWARD CHINE

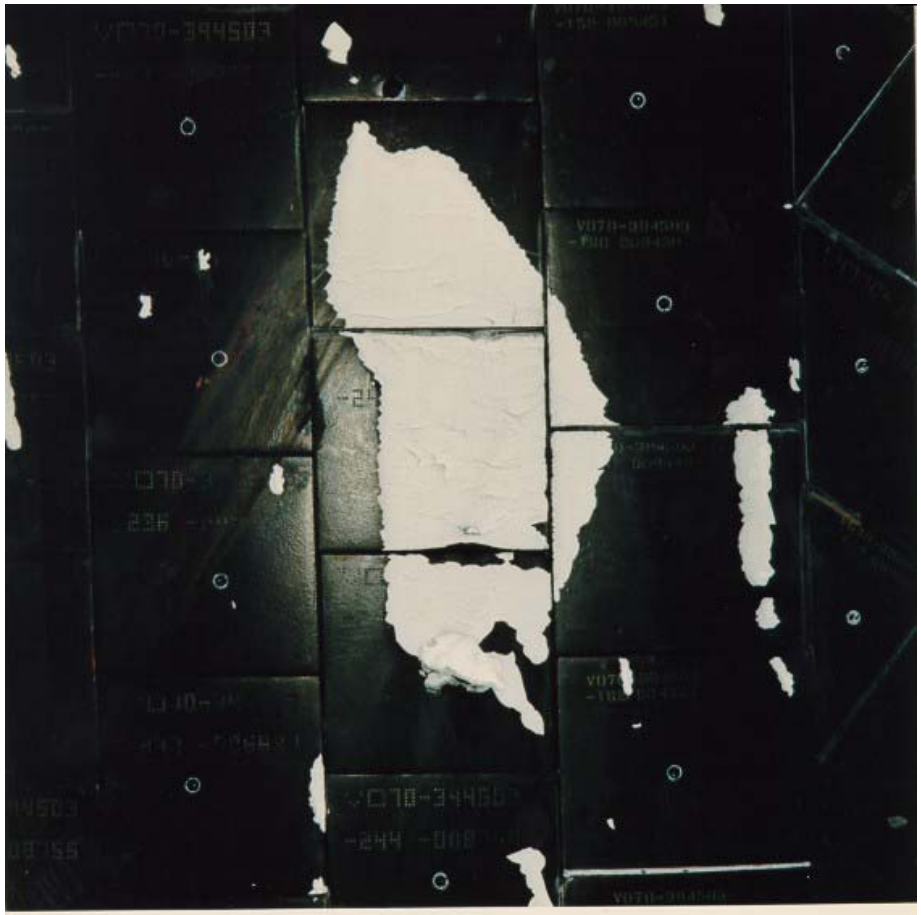
STS 27R Debris Damage

PHOTO #5. LARGE IMPACT GOUGE, DOWNSTREAM OF THE MISSING TILE

15” x 6” x XX” d

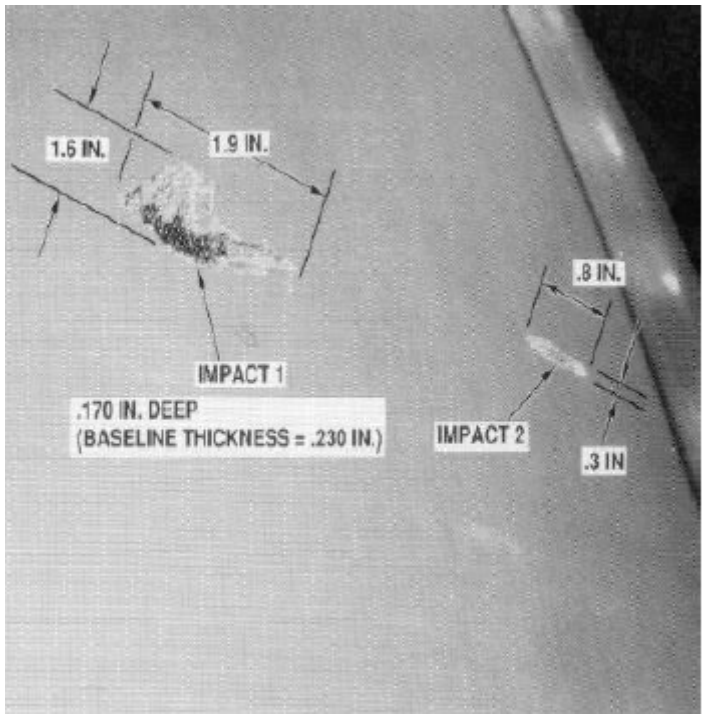
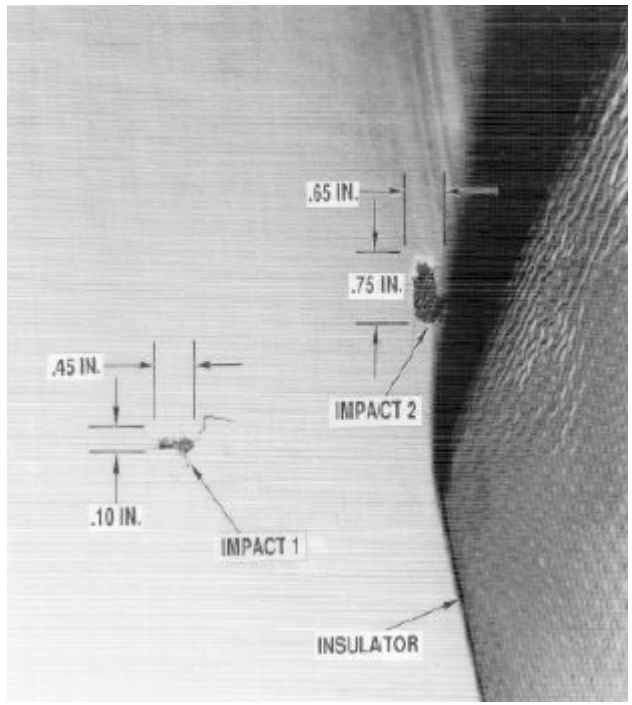
OV-104 Wing Leading Edge Panel 10 RH

Meteoroid/Orbital Debris Damage During STS-45

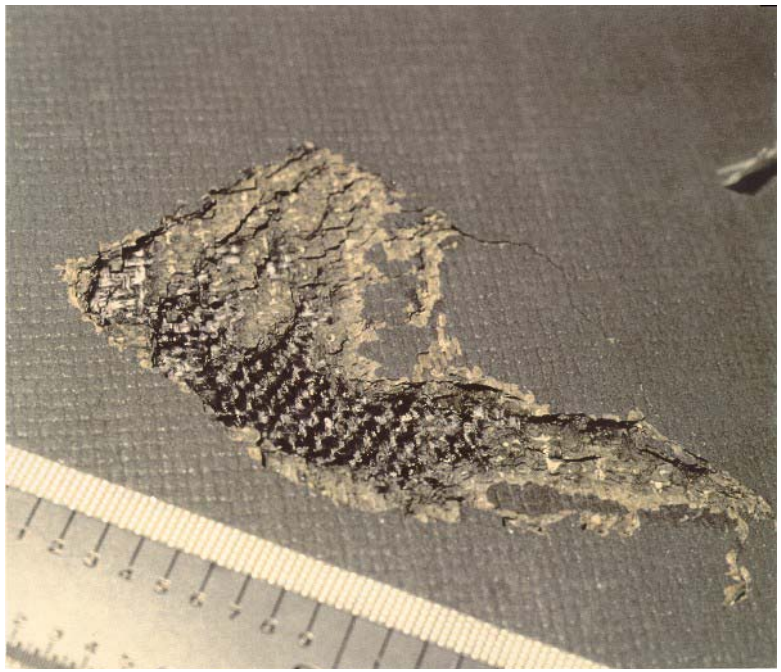
OV-104 Wing Leading Edge Panel 10 RH

Meteoroid/Orbital Debris Damage During STS-45
